Inspection Report

Property Address:
4711 Estmark Circle
Huntsville AL

The Insider Home Inspection

Date: 7/9/2014	Time: 01:00 PM	Report ID:
Property: 4711 Estmark Circle Huntsville AL	Customer: Nelson Witby	Real Estate Professional:

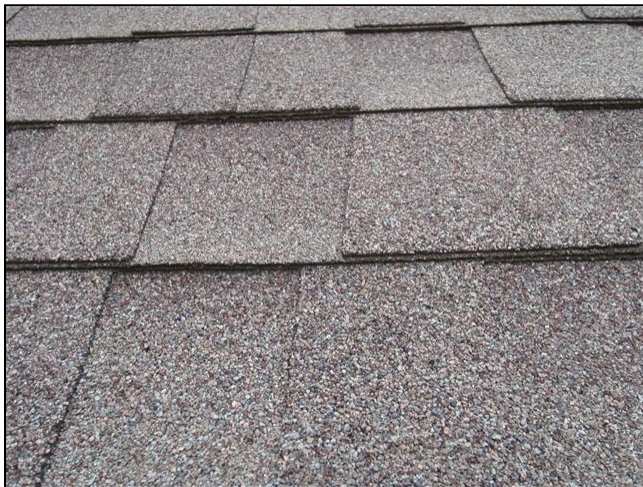
1.0 Item 1(Picture)

1.0 (1) Shingles are in serviceable condition at time of inspection.

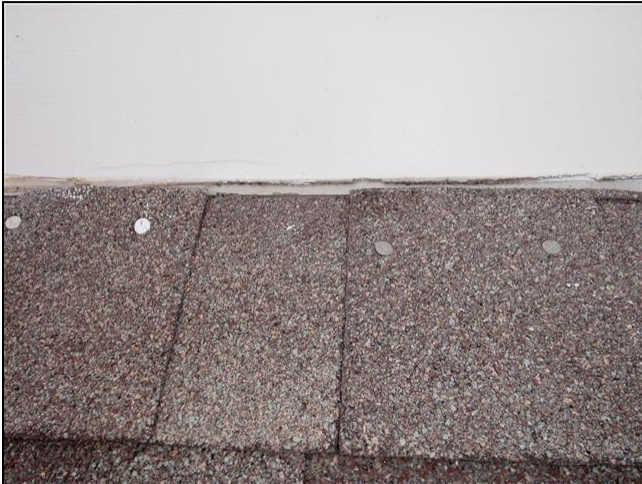
1.0 Item 2(Picture)

1.0 (2) This row of shingles is just above the rear deck. Recommend that exposed nail heads be covered with caulk or roofing tar.

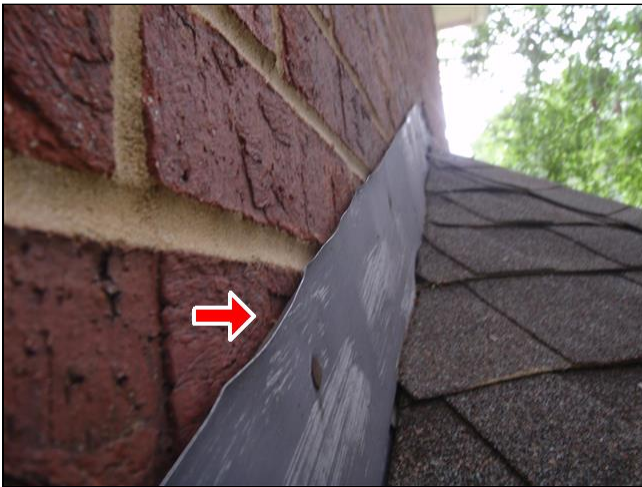
1.1 Item 1(Picture)

1.1 (1) Recommend caulking of upper edge of flashing (above bay window) to obtain weather tight seal.

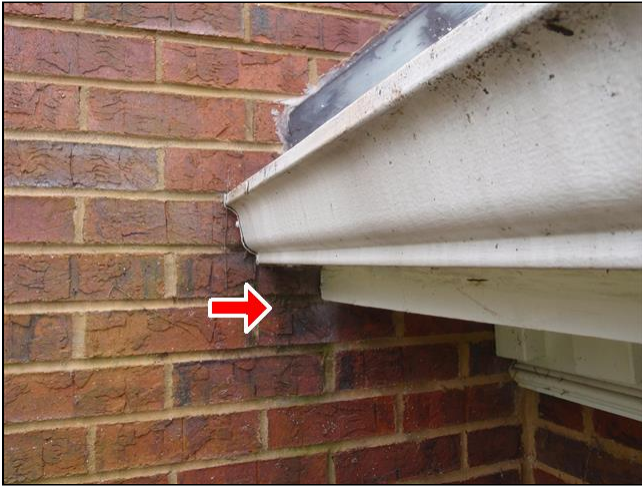
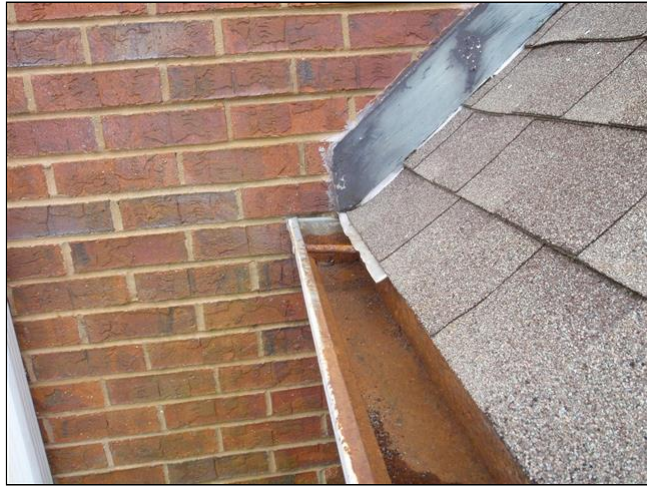
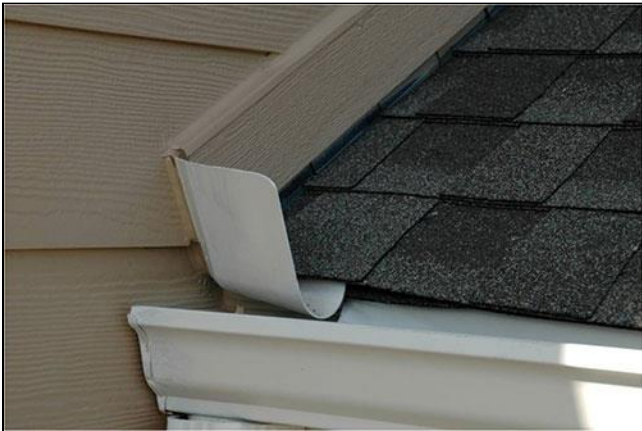
1.1 (2) This area (front of home) shows some sign of water overflow at end of gutter, running down brick surface below. This is common when roof lines terminate against a vertical surface as seen here. There is no evidence of damage to brick at this point, but customer may consider the addition of "kickout" flashing of the type seen in photo 3.

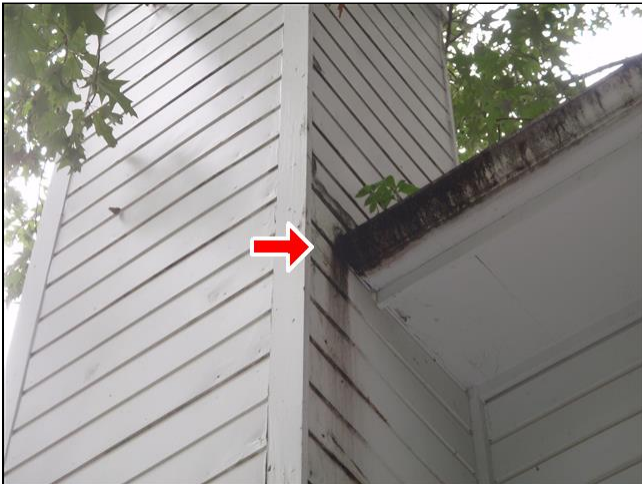
1.1 Item 5(Picture)

1.1 (3) Gutter overflow here, similar to section 1.2. Again, kickout flashing should be considered here, though this situation may be corrected by cleaning of gutter, which has obvious buildup of debris in this area.

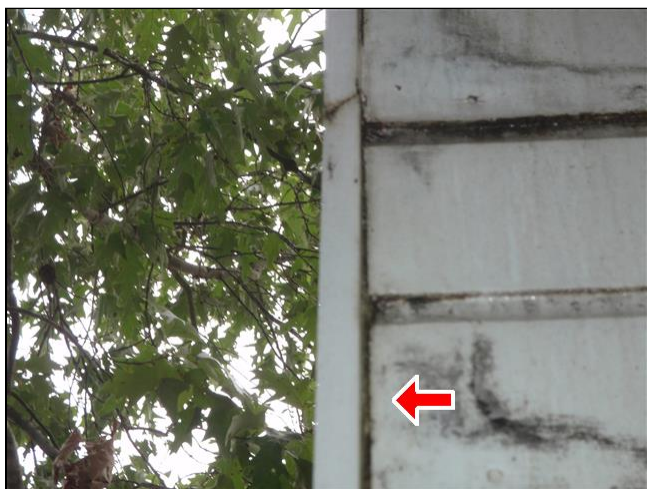
1.2 Item 1(Picture)

1.2 (1) Recommend caulking vertical edge of chimney corners to provide weather tight seal.

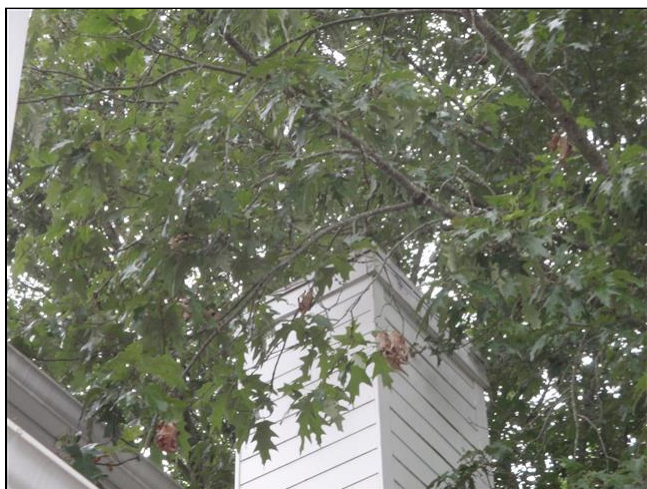
1.2 Item 2(Picture)

1.2 (2) Vegetation in contact with exterior surfaces can cause damage over time. Recommend trimming from chimney and any areas of contact with roof.

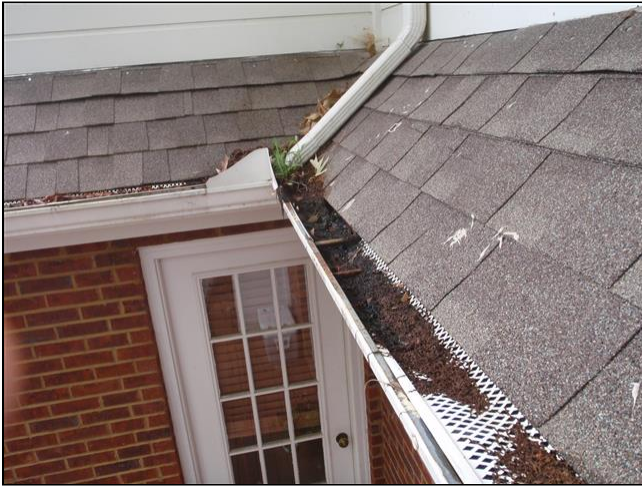
1.3 Item 1(Picture)

1.3 (1) A gutter guard system is in place in some areas and is deteriorated to the extent of improper function. If customer desires a gutter guard system, recommend repair. In any event, the system should be cleaned as part of regular home maintenance.

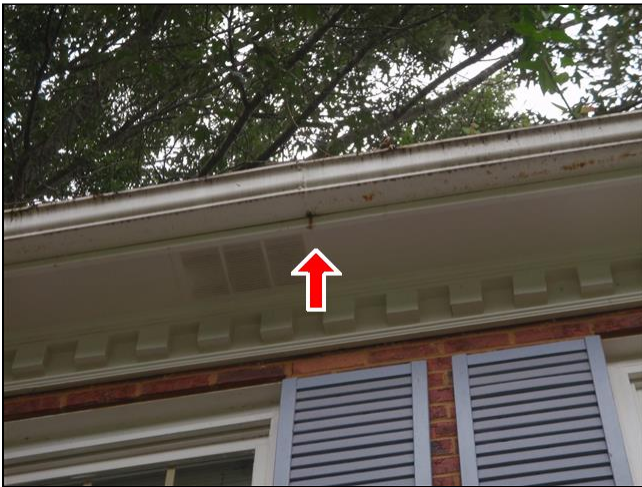
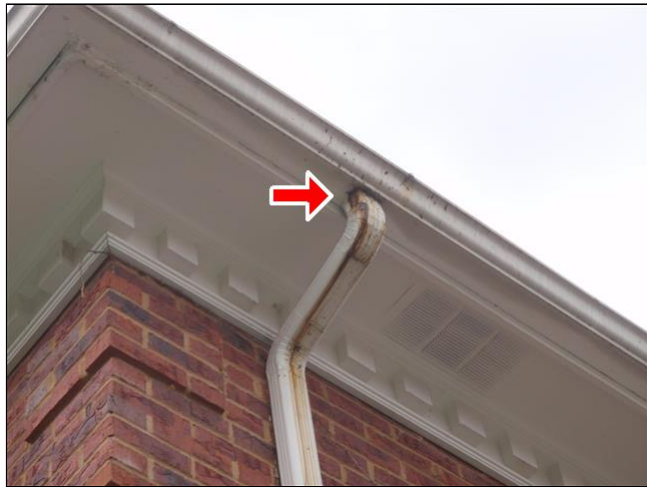
1.3 (2) Gutters are showing leaks in some areas, which is common as a gutter system ages. A gutter "tune up" is recommended.

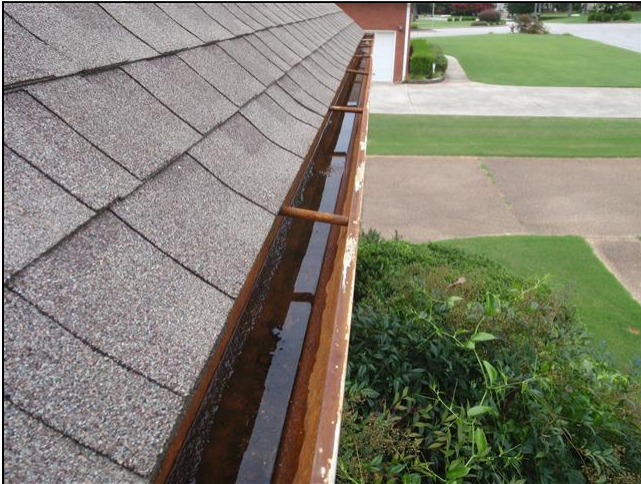
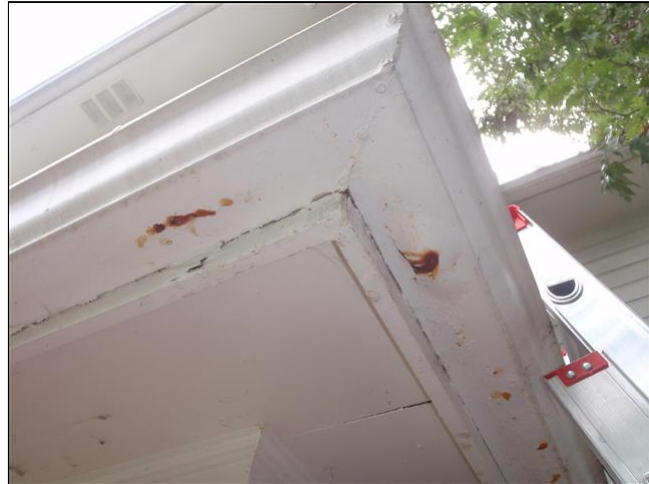
1.3 (3) Gutters showing rust in some areas. Recommend further evaluation by a gutter contractor to assess integrity of the entire gutter system.

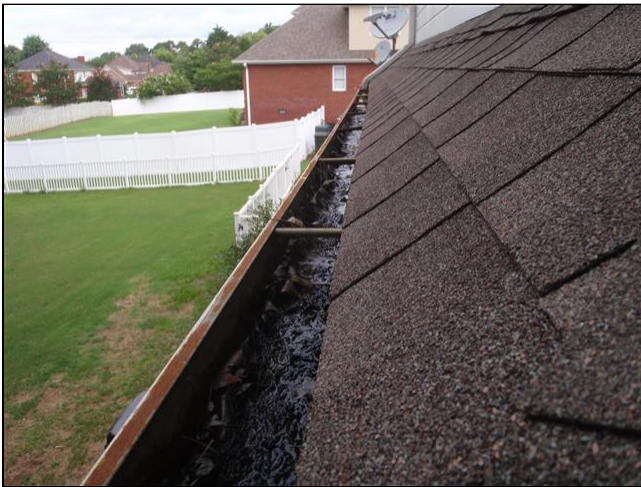
1.3 Item 6(Picture)

1.3 (4) Gutters clogged with debris in some areas. Recommend cleaning of entire gutter system.

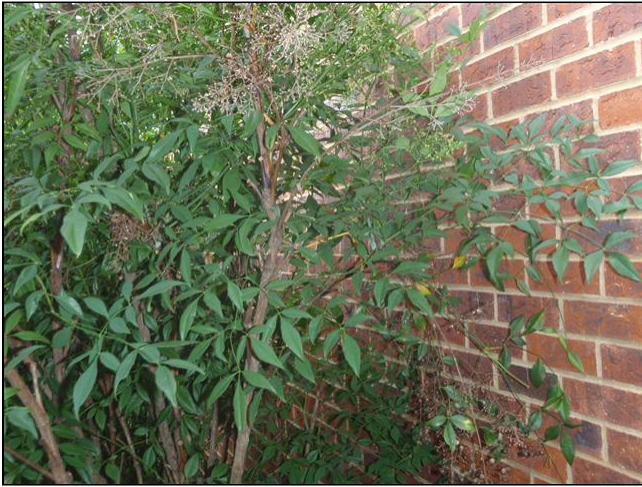
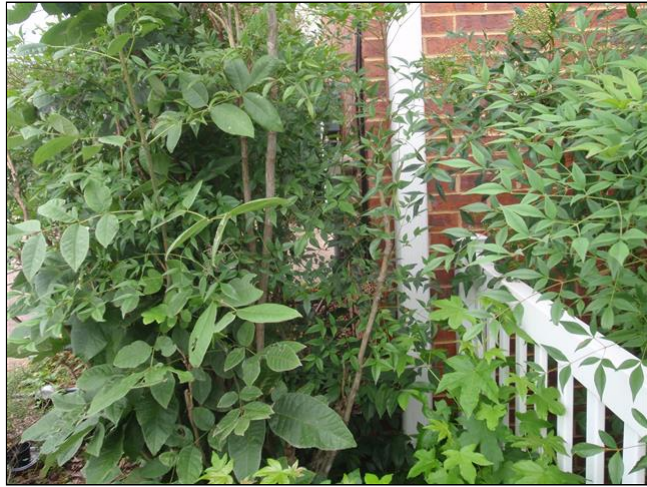
2.0 (1) Vegetation is contacting wall surfaces in several places, which can damage wall surface over time, facilitate pest entry, and hinder inspection and maintenance of wall surfaces. Recommend trimming vegetation to eliminate wall contact as needed. .

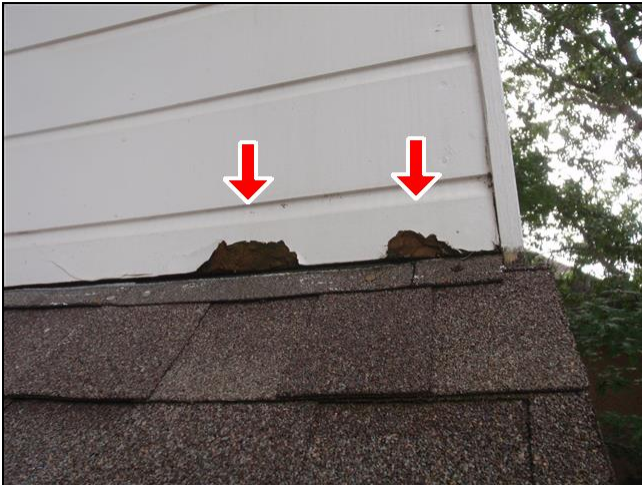
2.0 Item 3(Picture)

2.0 (2) Siding damaged around chimney. Recommend repair.

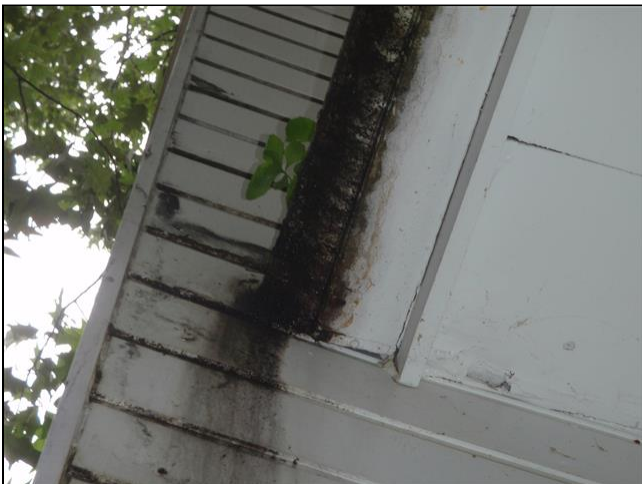
2.0 Item 4(Picture)

2.0 (3) Obvious clogging of gutter causing overflow of rain onto wall surface (rear of home). Recommend repair.

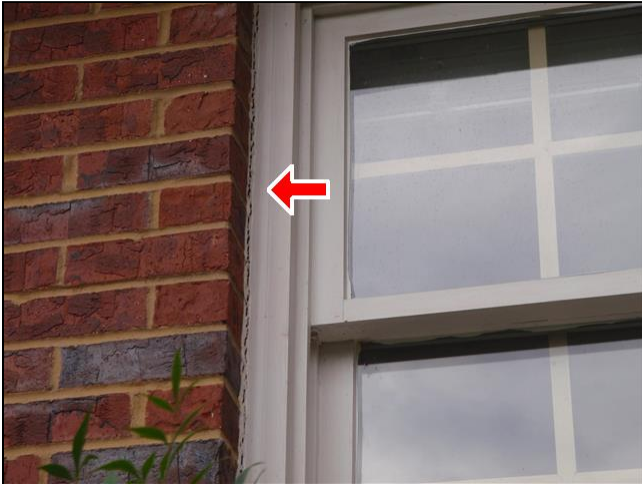
2.2 Item 1(Picture)

2.2 (1) Window at rear of structure needs caulk refresh on the vertical edge. No other window caulk deficiencies were obviously apparent, but it would be advisable that when this repair is done, check all windows and recaulk as needed.

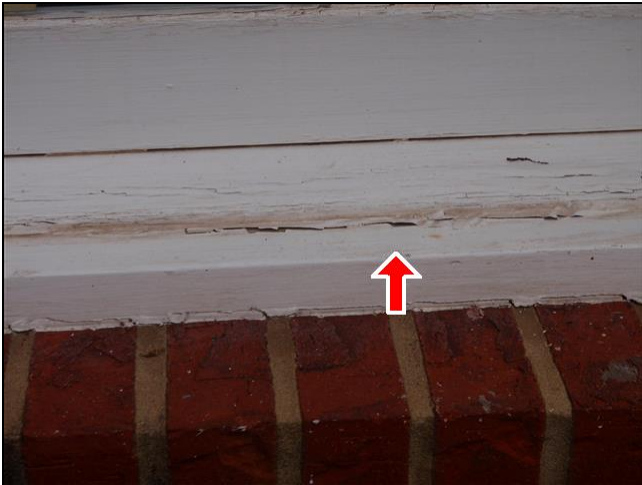
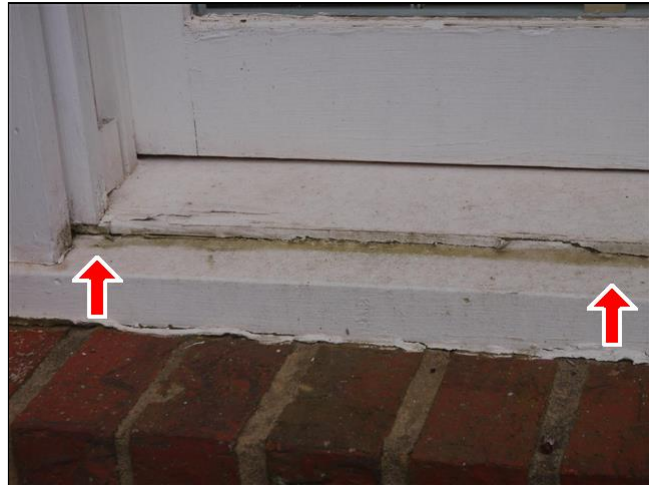
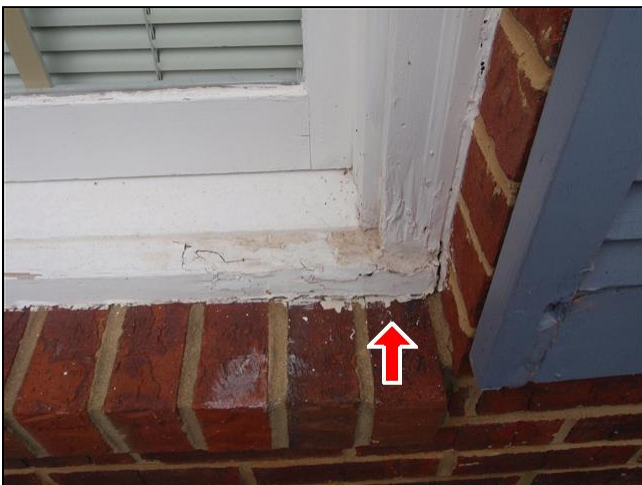
2.2 (2) Two windows (front of home) showing some damage to casing. Recommend repair. When this repair is done, it is advisable to evaluate all windows, repair as needed.

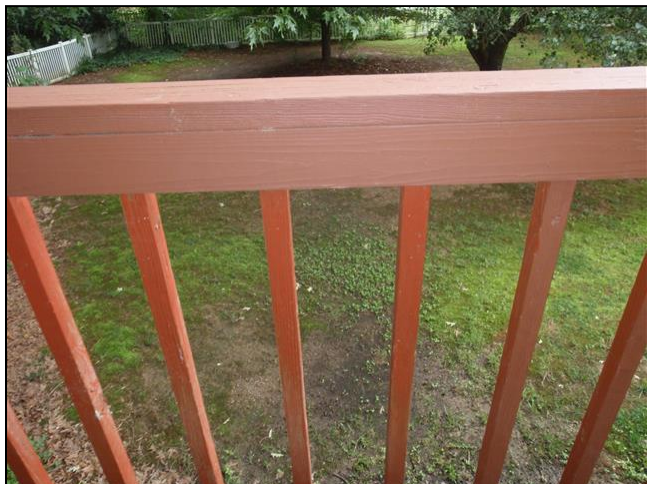
2.3 Item 1(Picture)

2.3 (1) Spindles on deck railing exceed 4" of spacing (the modern safety standard). Recommend adjusting spindles to no more than 4" of separation.

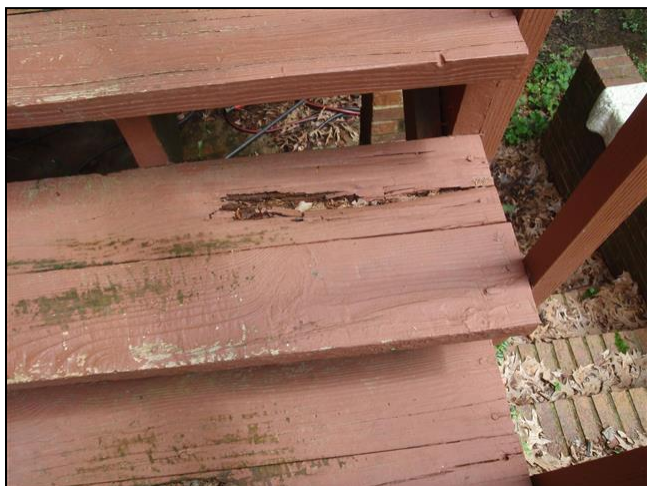
2.3 Item 2(Picture)

2.3 (2) Steps from deck have some damage and at least two treads are loose, moving when stepped on. Recommend repair.

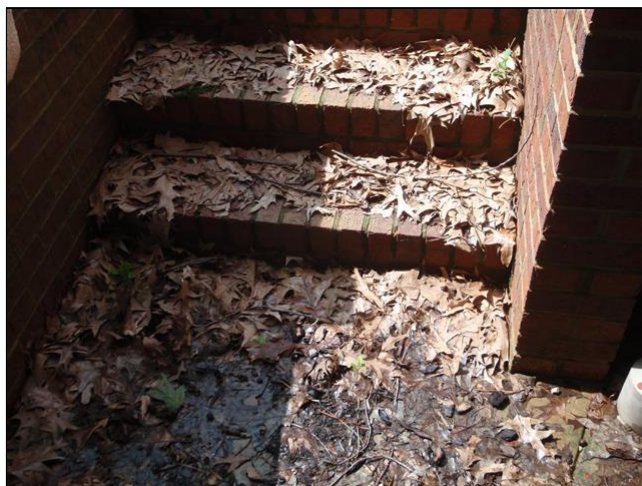
2.3 Item 3(Picture)

Brick steps from lower patio are covered in debris, which could present trip hazard. Recommend cleaning.

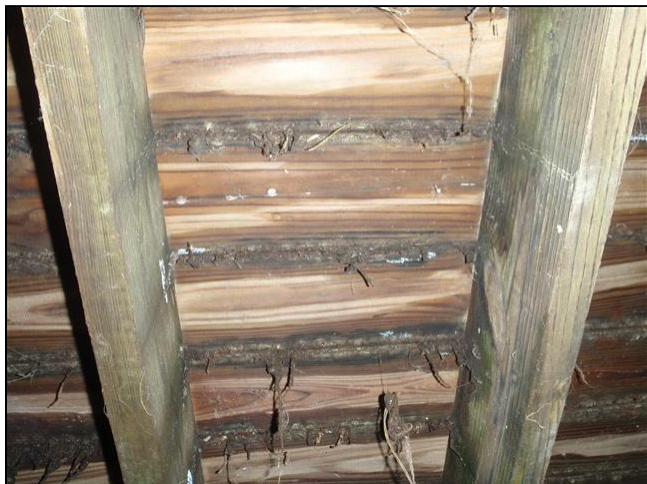
2.3 Item 4(Picture)

2.3 (3) Dead vegetation is clinging to deck in many places, which can cause damage over time. Recommend removal of debris.

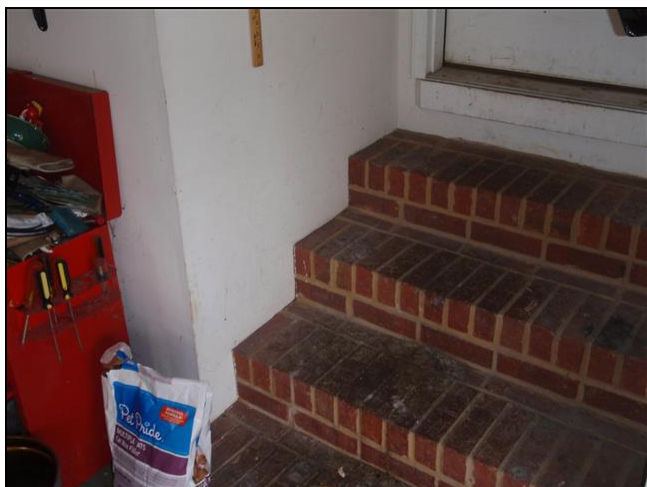
2.3 Item 5(Picture)

2.3 (4) Vertical rise of steps from garage into house exceeds 24". Customer may consider adding handrails as safety upgrade.

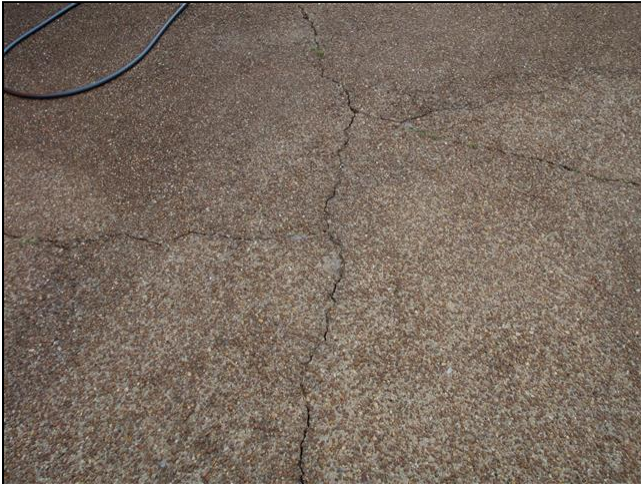
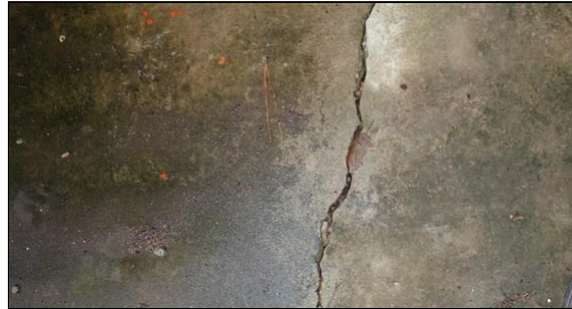
2.4 (1) Driveway and patio show some cracking, which is common in concrete surfaces. Not structural concern or safety issue. No action recommended.

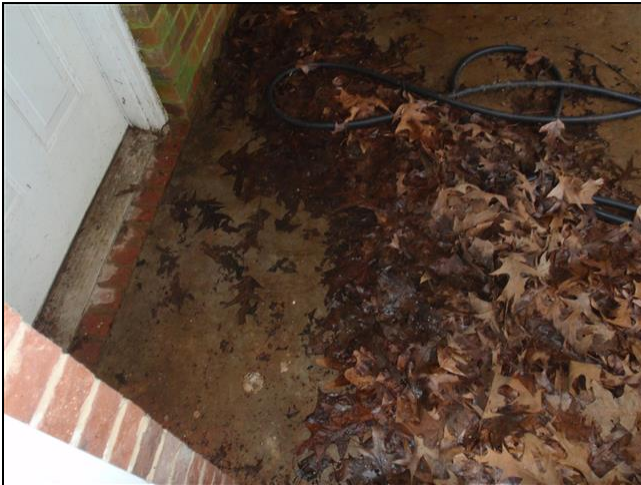
2.4 Item 3(Picture)

2.4 (2) Patio (under deck) does not have slope to drain away from structure and holds water. Customer should consider taking steps to provide for adequate drainage.

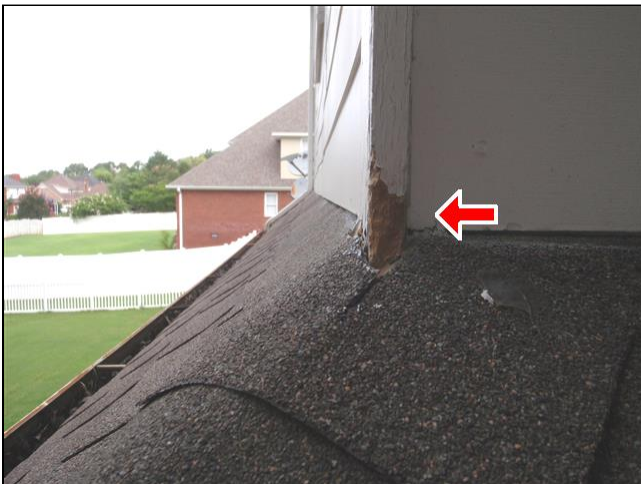
2.5 Item 1(Picture)

2.5 (1) Exposed wood at this corner above deck. Recommend repair.

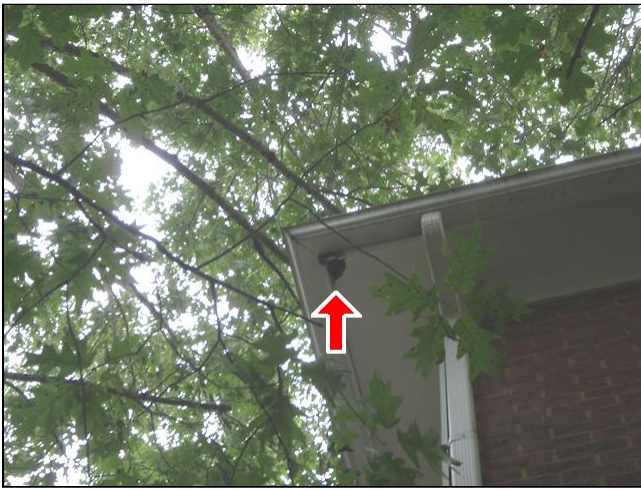
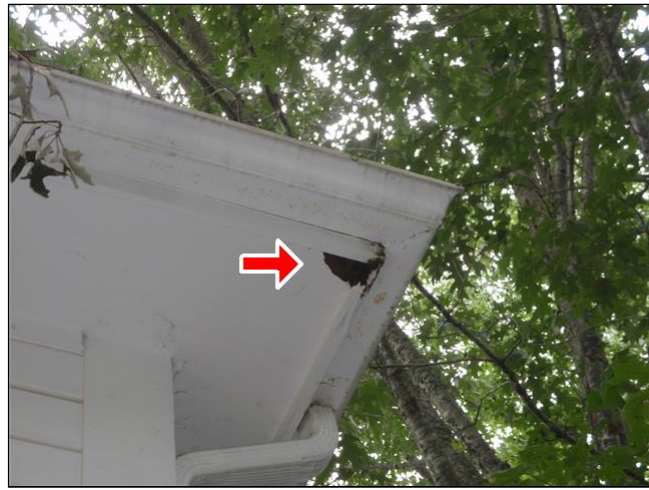
2.5 (2) Damage to fascia board and soffit at rear corner of house, apparent result of gutter leak. Recommend repair.

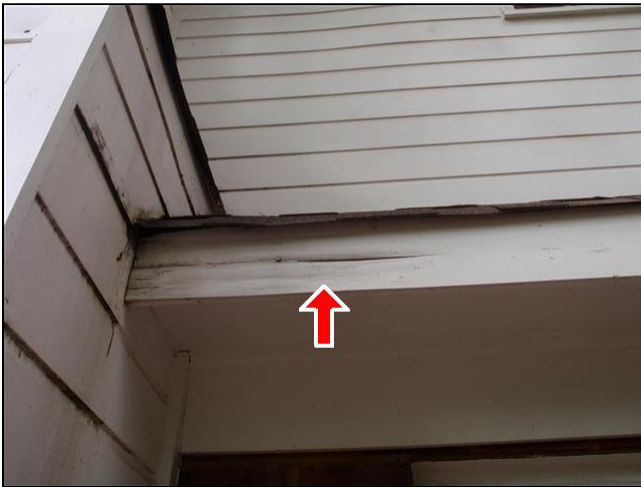
2.5 Item 4(Picture)

2.5 (3) This fascia board above deck, adjacent to chimney, showing weather damage. Recommend repair.

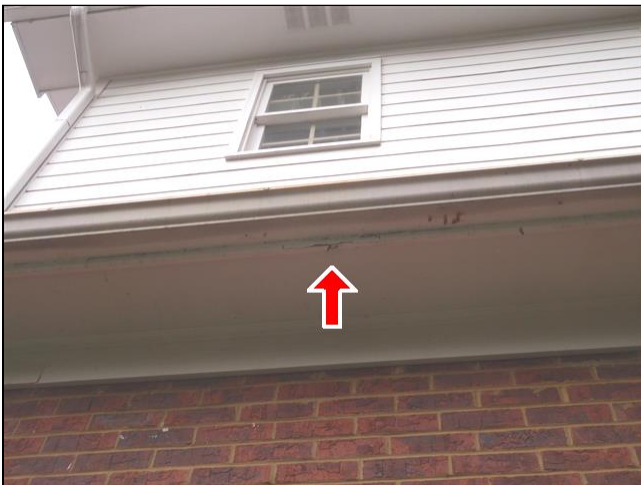
2.5 Item 5(Picture)

2.5 (4) Damage to fascia (under gutter edge, rear of home). Recommend repair.

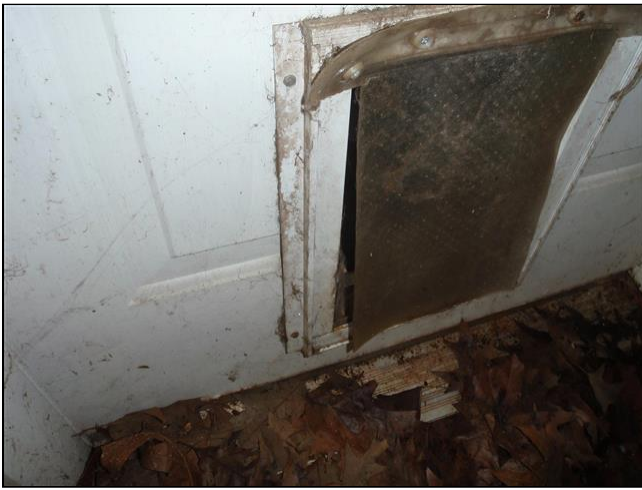
2.6 Item 1(Picture)

2.6 Pet door (rear patio) does not close tightly and could allow pest entry. Recommend repair.

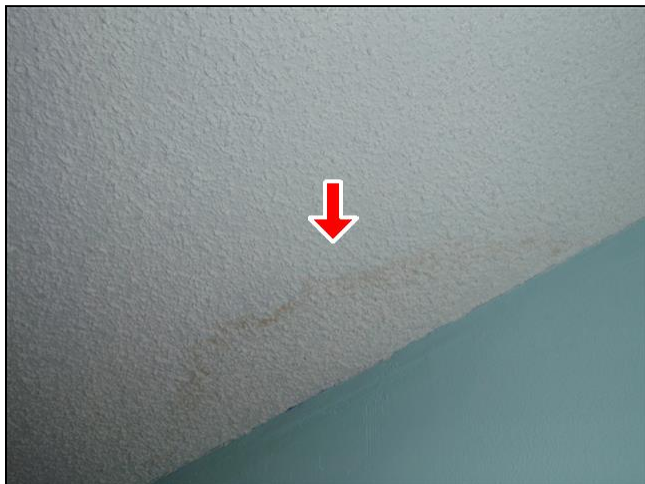
4.0 Item 1(Picture)

4.0 There is evidence of a leak on ceiling in hall bath. However, this appears to be an old leak and may not represent a current issue. In the absence of rain, active leaks cannot be identified for certain. Suggest monitoring.

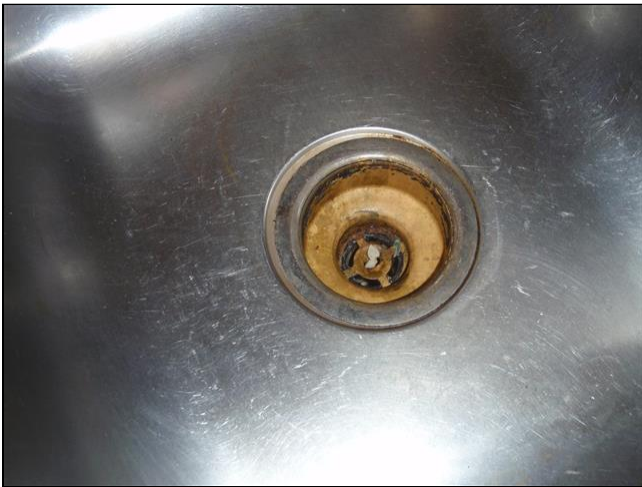
6.1 Item 1(Picture)

6.1 (3) Kitchen sink drain showing corrosion. Not a functional concern. Customer may consider repair as desired.

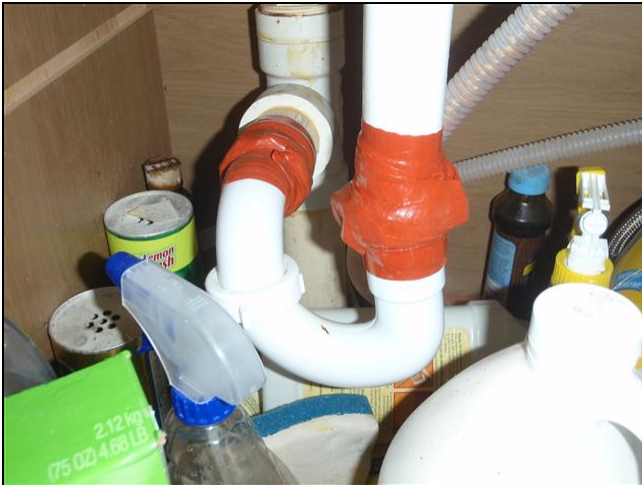
6.1 Item 2(Picture)

6.1 (4) Drain trap under kitchen sink appears to be bowed slightly and is sealed with tape. Though drain was tested and showed no leak, this is an unconventional practice which should not be considered acceptable for long term function. Recommend repair by plumbing contractor.

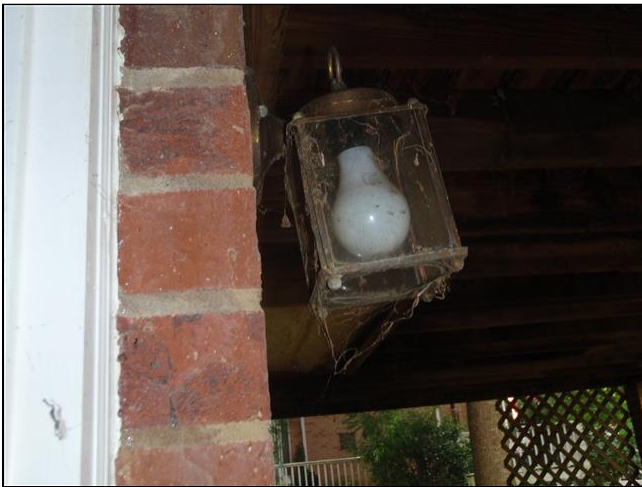
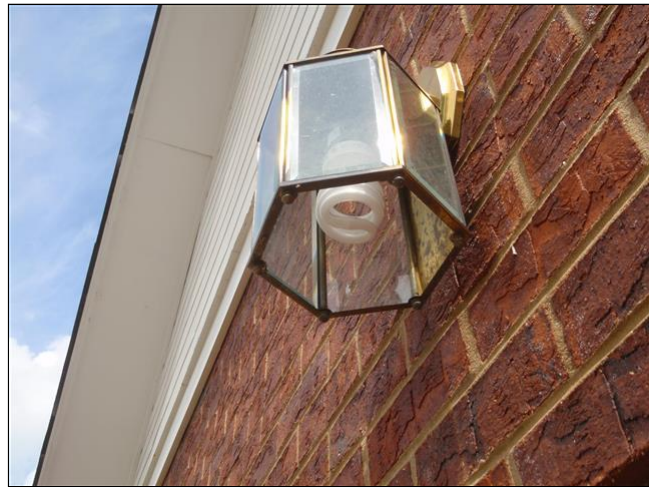
7.3 (1) Patio light (under deck) and fixture above garage door would not illuminate. Recommend change of bulbs and retest.

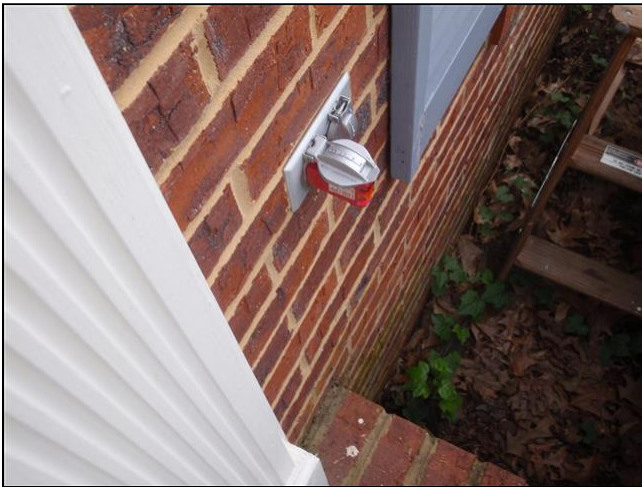
7.3 Item 3(Picture)

7.3 (2) Exterior receptacle (by front door) is non-functional. Recommend repair.

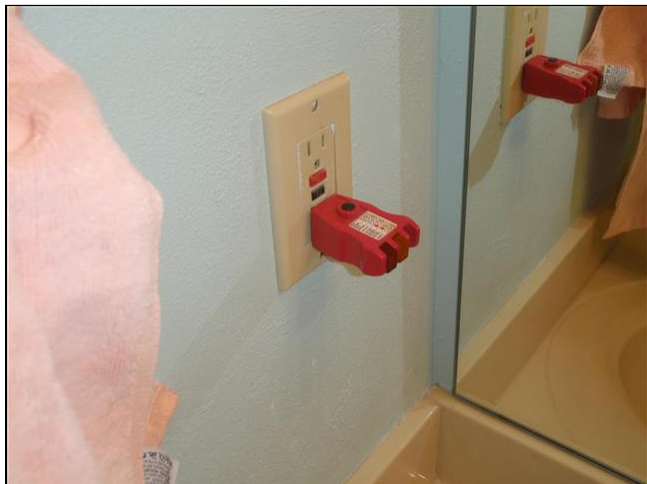
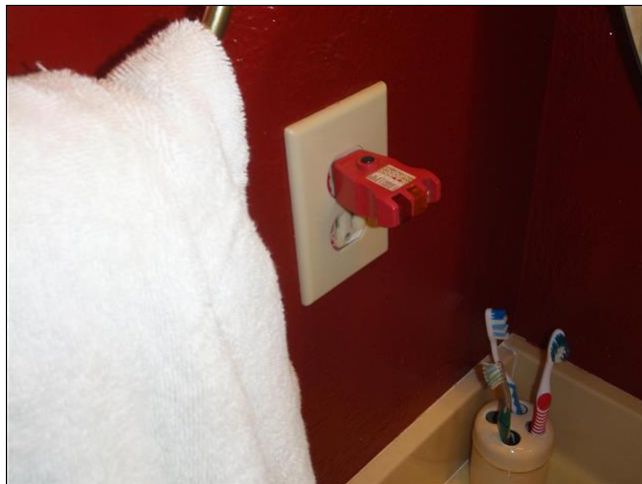
7.5 GFCI receptacle (hall bath) is non-functional. Recommend repair by electrical contractor.

Master bath receptacle non-functional. Recommend repair.

Exterior receptacle (main level, wood deck) is not GFCI protected. GFCI receptacles are safety features (standard in modern construction) for applications within six feet of a water source, in garages, and exterior applications. Customer should consider adding GFCI in these areas as safety upgrade.

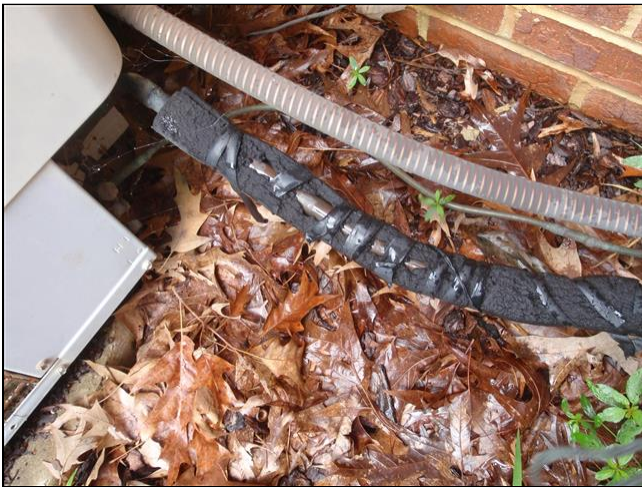
8.3 Item 1(Picture)

8.3 (1) Cooling line insulation is deteriorated. Recommend repair.

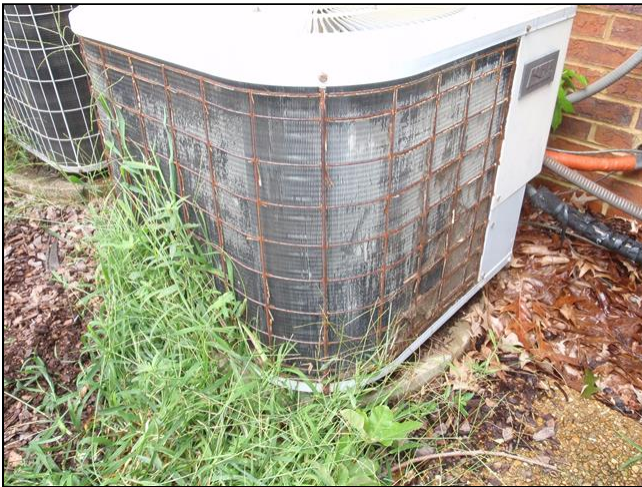
8.3 Item 2(Picture)

8.3 (2) Vegetation should be trimmed and debris cleared from unit.

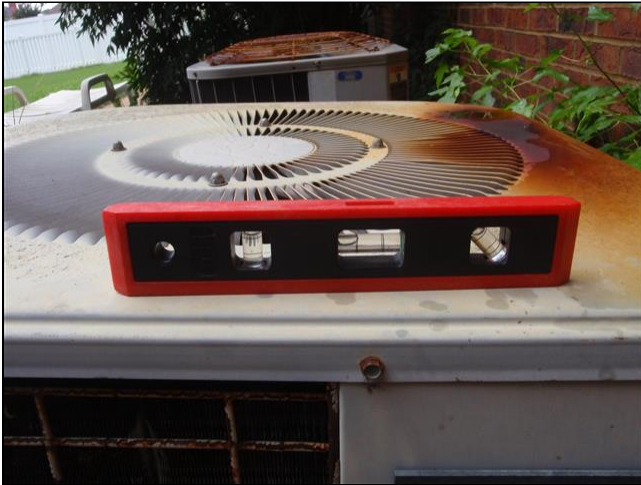
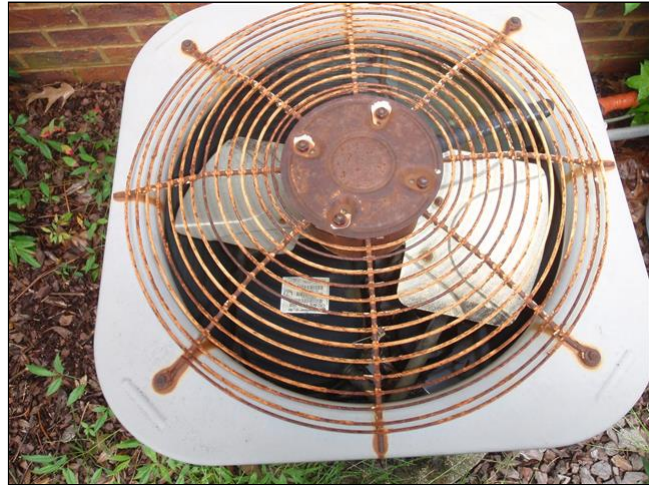
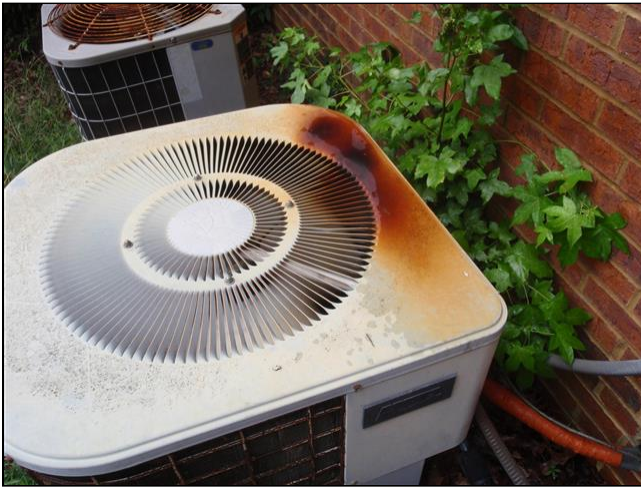
8.3 (3) Unit is on unlevel pad, which can shorten operating life of unit. Recommend adjustment. Unit is beginning to rust, as water accumulates because of leaking gutter above. Recommend repair. Units are showing rust and wear but are serviceable at time of inspection.

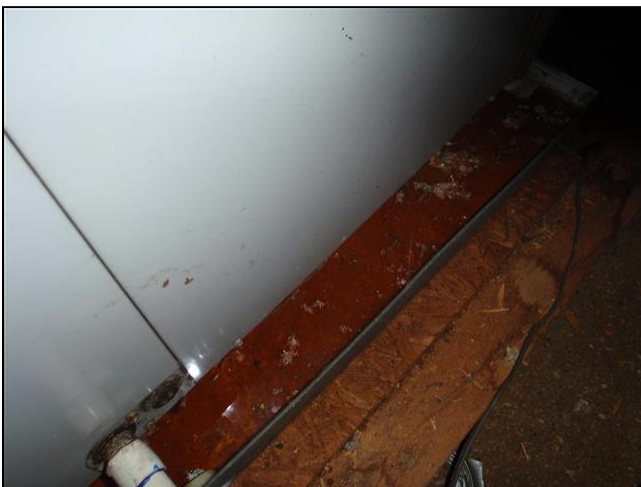
8.8 Item 1(Picture)

8.8 Air handler drip pan (located in attic) is holding water and showing rust. Recommend evaluation by AC contractor.

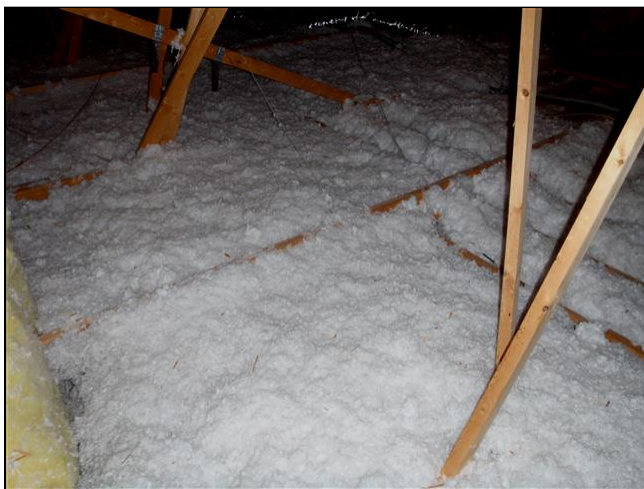
9.0 Item 1(Picture)

9.0 Insulation has settled and is of inconsistent depth, averaging 6-8", which will not provide the modern standard R-30 insulation level. Customer may consider an insulation refresh to enhance energy efficiency.
